DOCKING REPORT OF VESSEL

RUHUNA -01 PILOT BOAT

Location of docking – Hambantota International Port Group no 08 Pier.

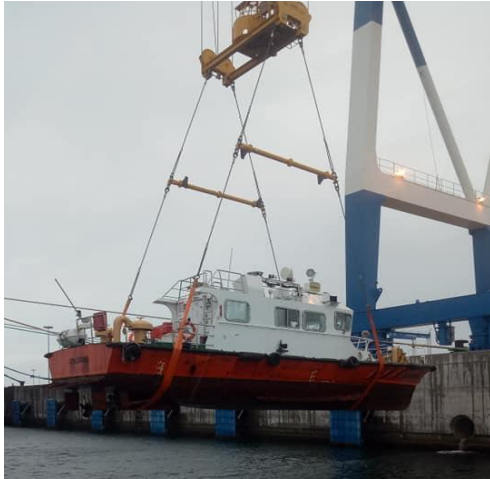
Boat lifting and positioning on cradle done by HIPG crew

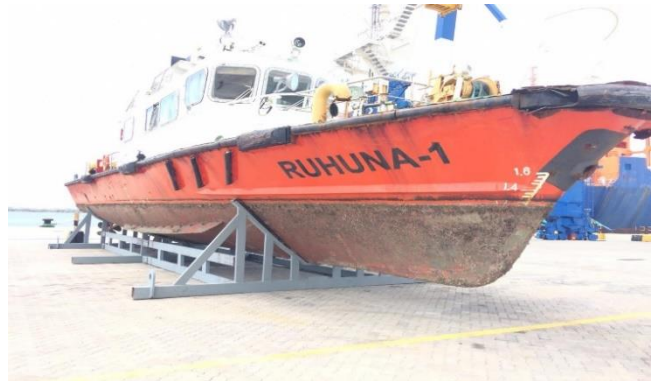
After positioning

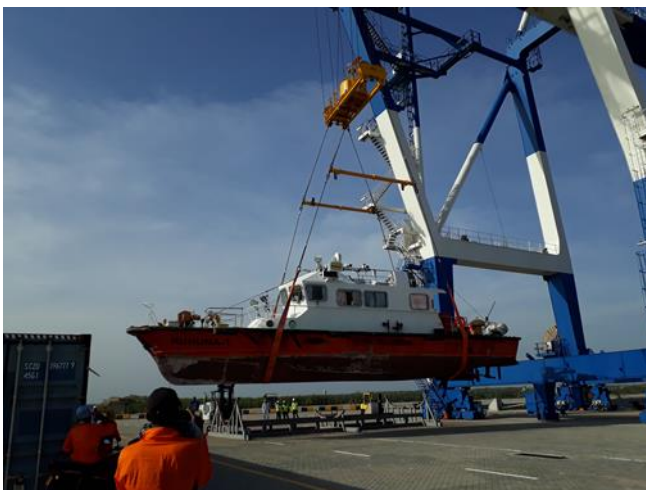
During boat positioning

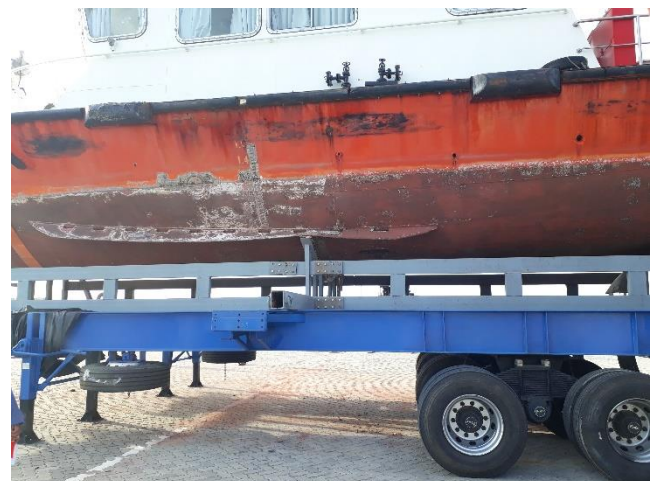
After positioning

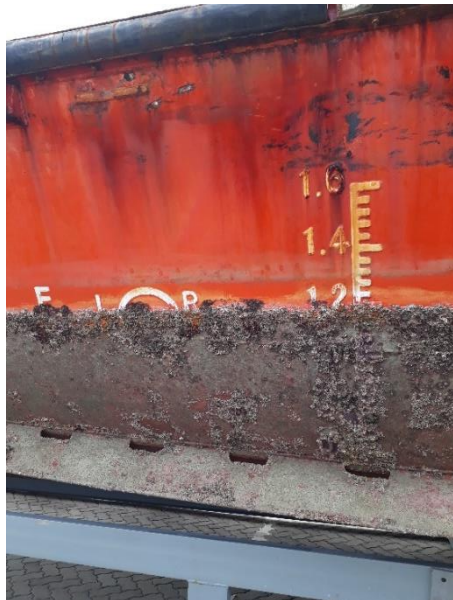
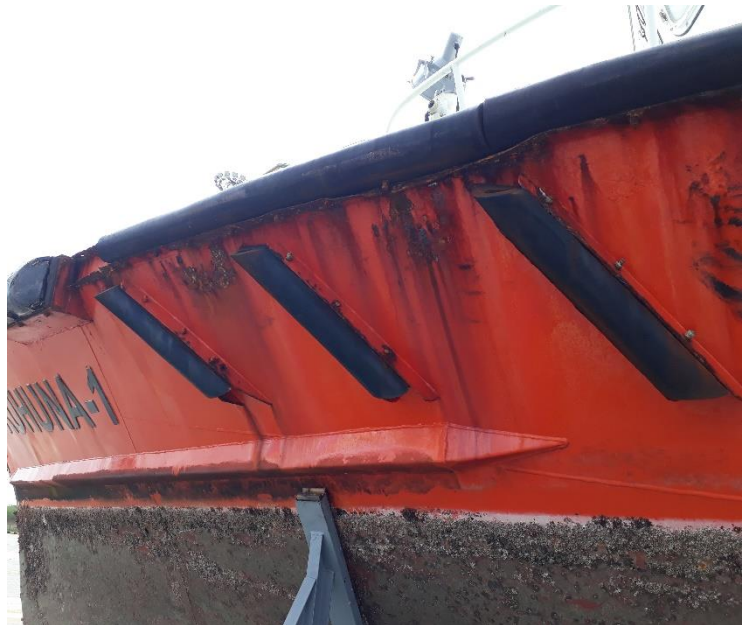
Before scrape barnacles

Barnacles removing manually by hand scrapers, under water hull area, propellers both side, rudders both side, and propeller shafts and sea chest gratings.

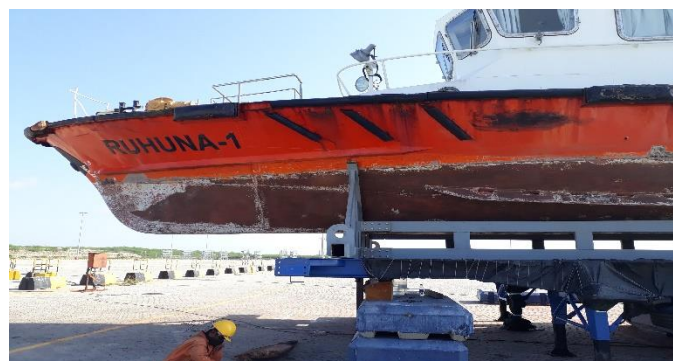
After scrap, & brushing

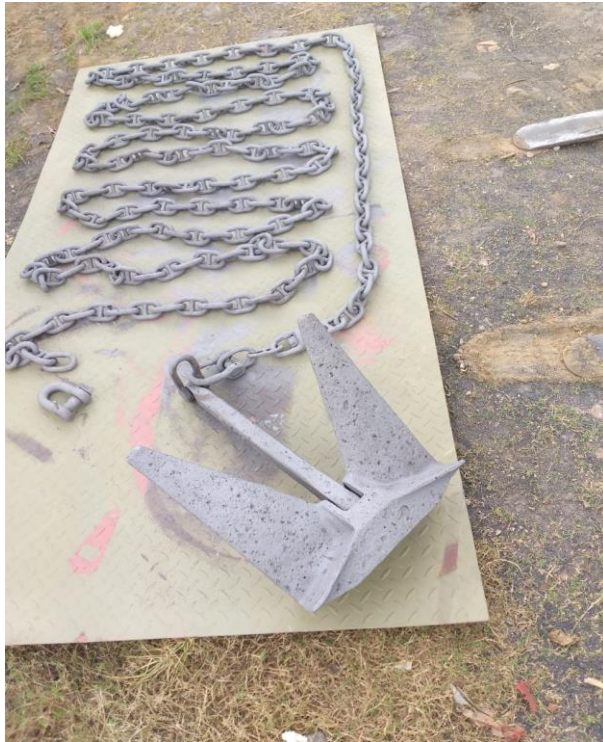
After blasting

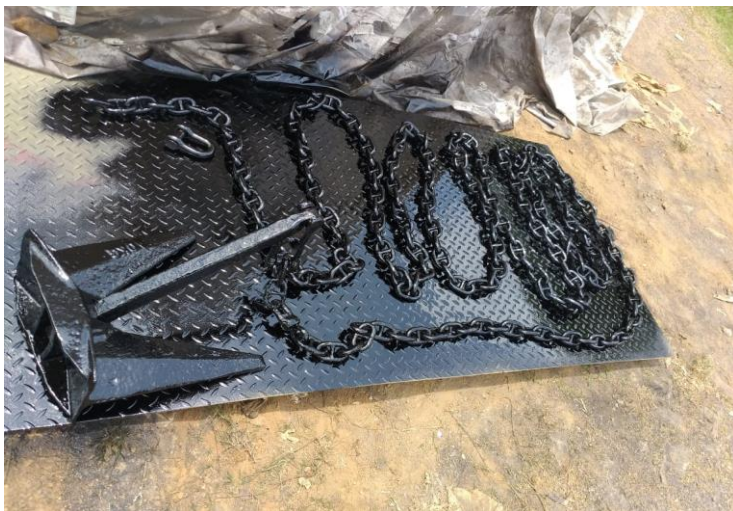
After painting

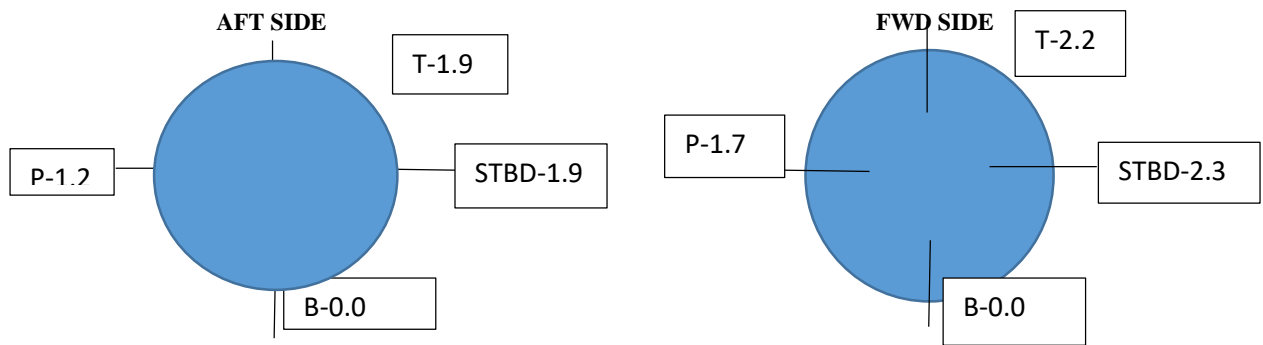
A) PROPELLER SHAFT “P” BRACKET BUSH CLEARANCE PORT SIDE

PROPELLER SHAFT					
SHAFT DIAMETER “P” BRACKET AREA		PORT SIDE SHAFT - 85		STBD SIDE SHAFT - 85	
		FWD	AFT	FWD	AFT
“P 1” BRACKET BUSH	T	2.2	1.9	1.7	1.2
	B	0.0	0.0	0.0	0.0
	P	1.7	1.2	1.4	0.2
	S	2.3	1.9	1.2	0.3
“P 2” BRACKET BUSH	T	N.A	N.A	N.A	N.A
	B	N.A	N.A	N.A	N.A
	P	N.A	N.A	N.A	N.A
	S	N.A	N.A	N.A	N.A

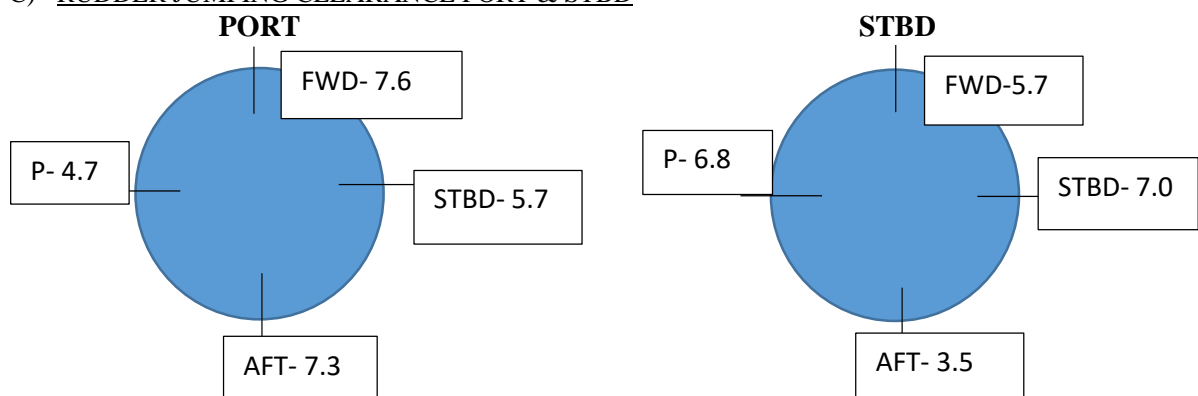
C) RUDDER JUMPING CLEARANCE PORT & STBD

RUDDER				
PINTLE DIA- N.A	PORT SIDE		STBD SIDE	
	TOP BUSH	BOTTOM BUSH	TOP BUSH	BOTTOM BUSH
FORWARD	N.A	N.A	N.A	N.A
AFT	N.A	N.A	N.A	N.A
PORT	N.A	N.A	N.A	N.A
STBD	N.A	N.A	N.A	N.A
JUMPING CLEARANCE	PORT SIDE		STBD SIDE	
	FWD	7.6	FWD	5.7
	AFT	7.3	AFT	3.5
	P	4.7	P	6.8
	STBD	5.7	STBD	7.0
REMARKS:-				
<ul style="list-style-type: none"> Bush clearance will be submitted after withdrawal of the rudder Since we observed both rudders seals were damage, hence we decided to withdraw the rudder to facilitate renewal of water seals and to obtain rudder bush clearances physically.

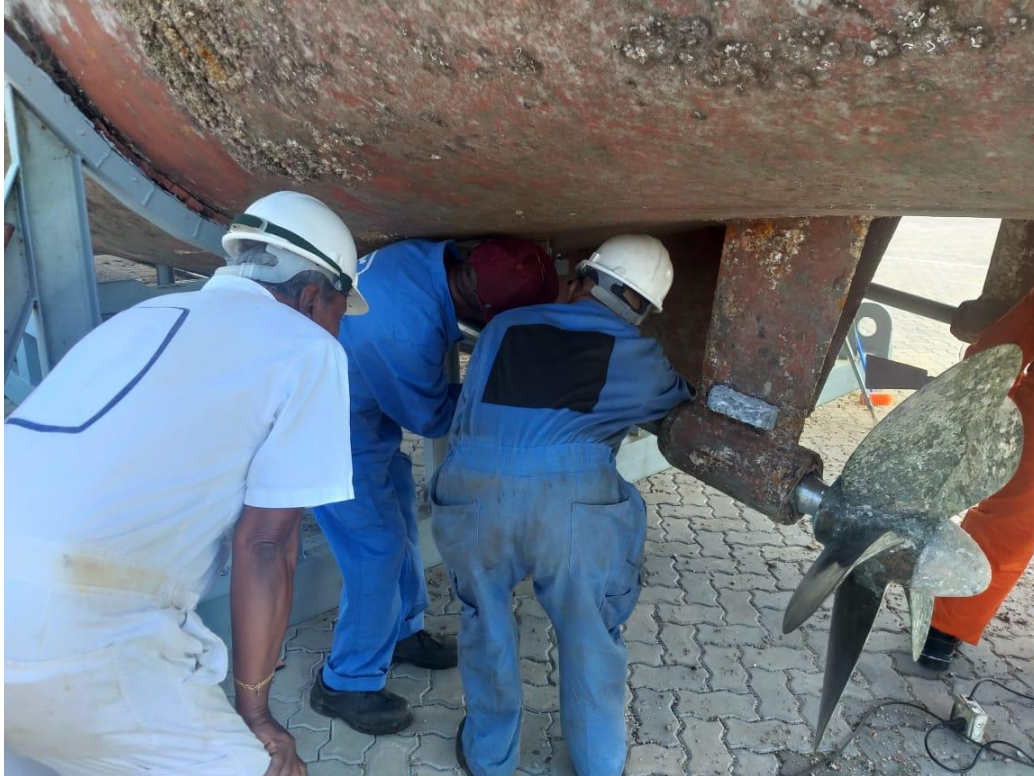
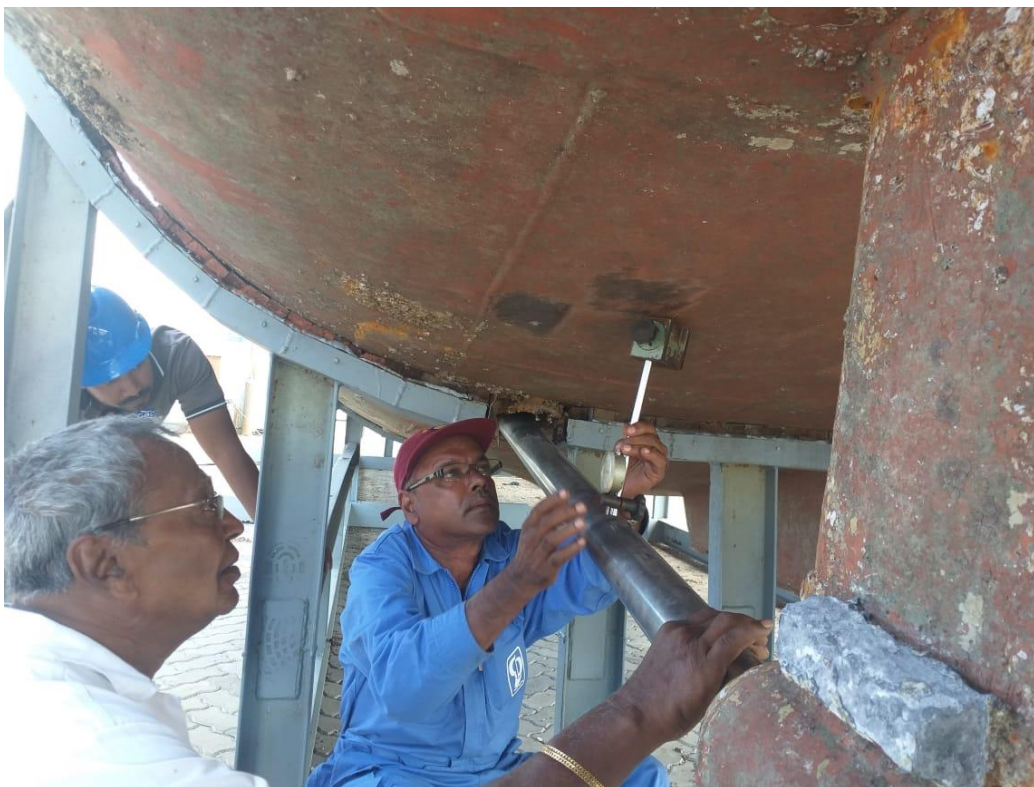
Shaft alignment checking by dial gauge

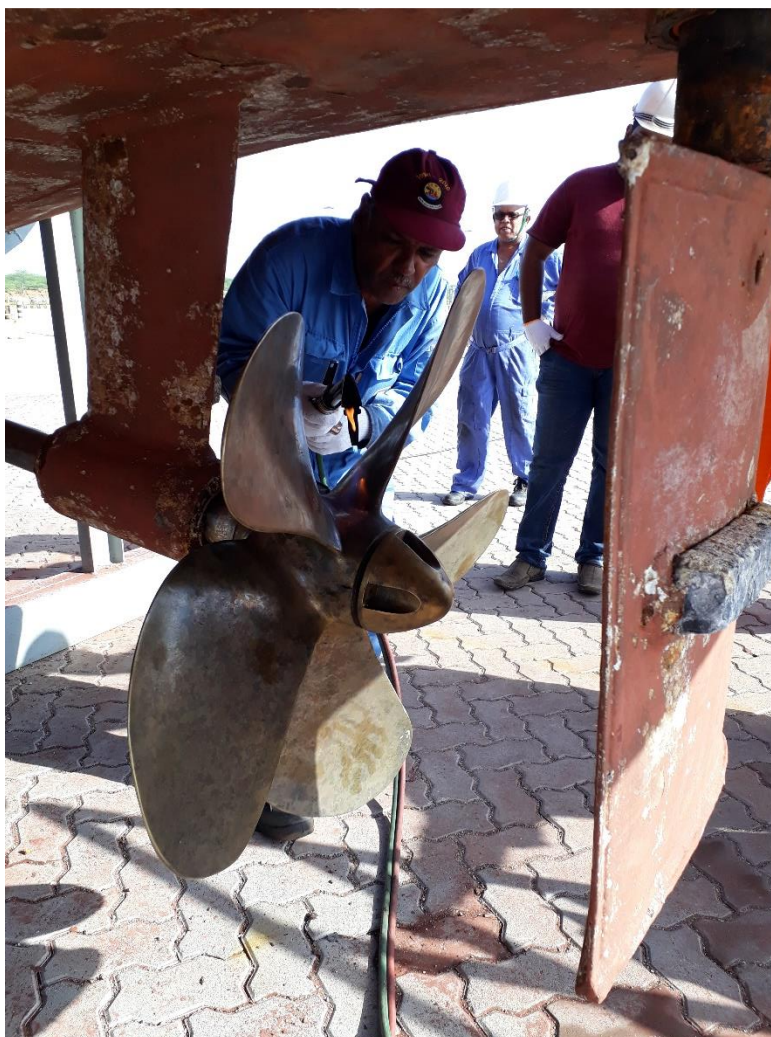
Remove propellers, for remove to propeller cone nut fabricate new spanner tool from 20mm thickness plate. Scaffolding stage arrange around after side for remove propellers. Remove cone nut using fabricated tool and get it down and inspection propeller key way and S/S Allen bolts condition. During inspection appear STBD side S/S allen bolt damage. Supply S/S allen bolt. STBD side propeller hard to remove easily, previous time propeller was tide pushup.

During removing propellers

Then we have to use high 4nos tension studs, and high tension nuts for loose propeller

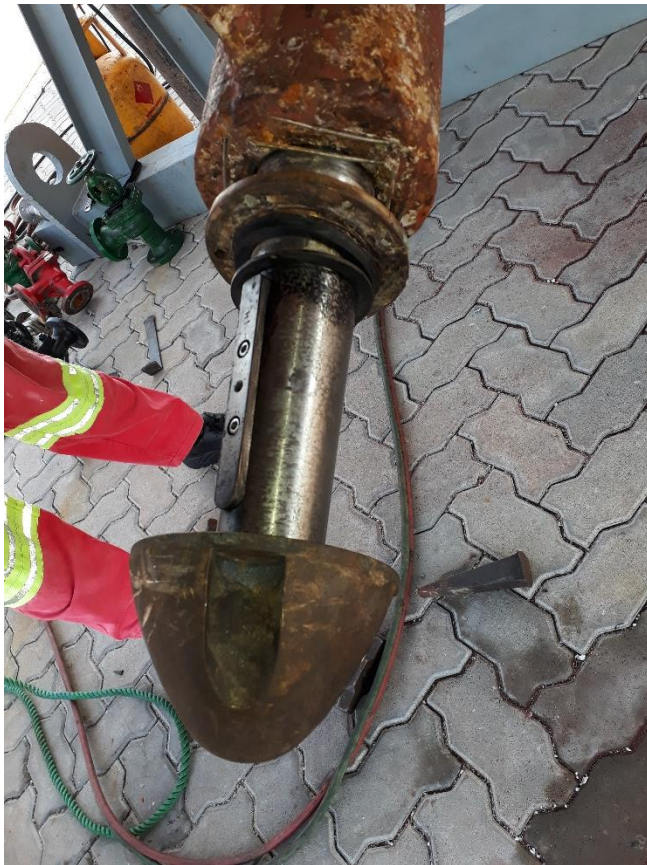
P side SS allon bolt head damage

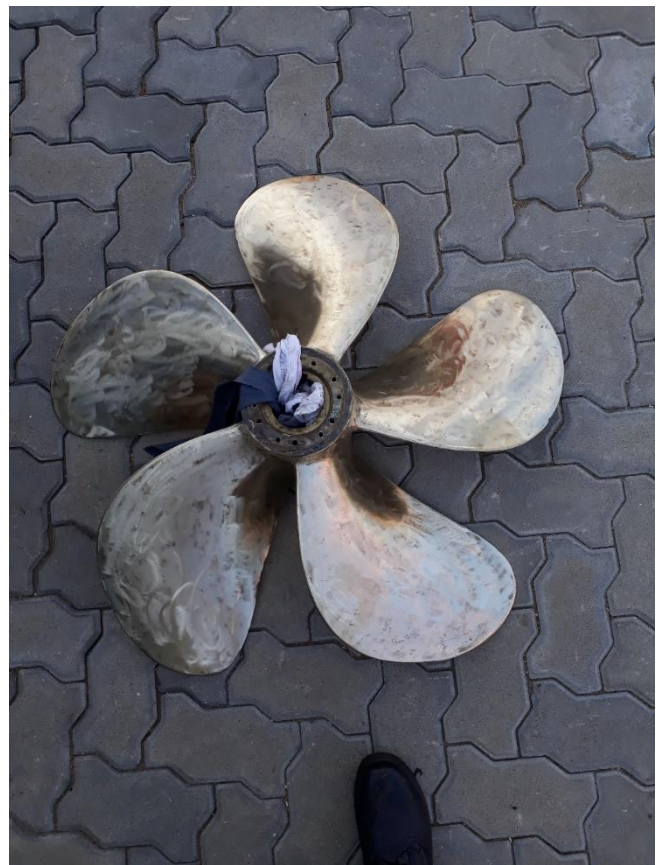
Light polish propellers

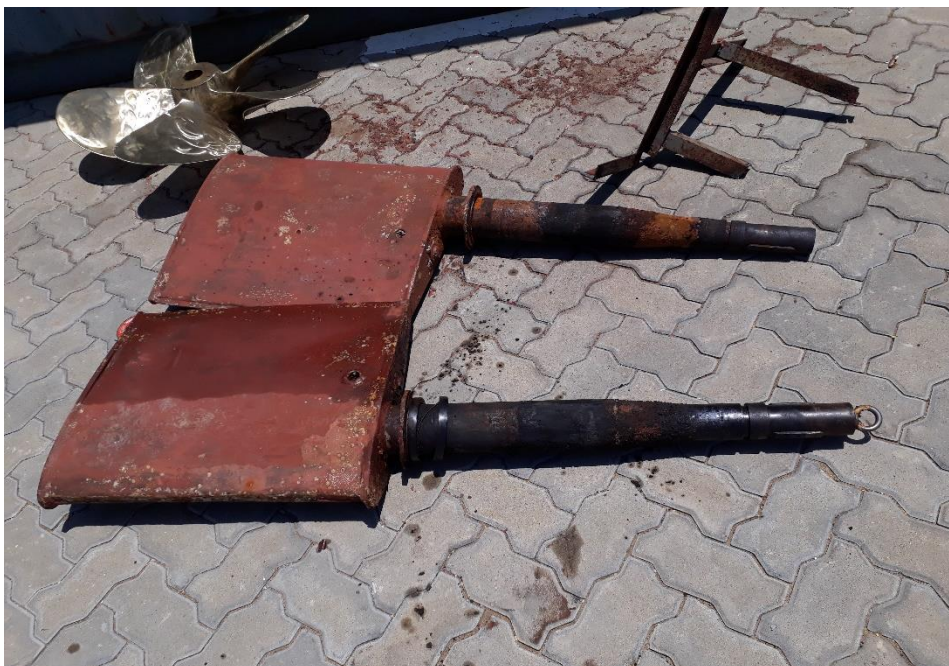
After remove the rudders

- Measuring rudders jumping clearance.
- Port & stbd rudders dismantled -When we inspection rudder condition initially there is a considerable play appeared so we have to dismantle rudder jumping clamps and rudder stock get them down.
- Rudder stock bearings and oil seals are badly worn, due to worn seals allow entrance for sea water to tiller plat area. Rudder bearings and oil seals are renewal.

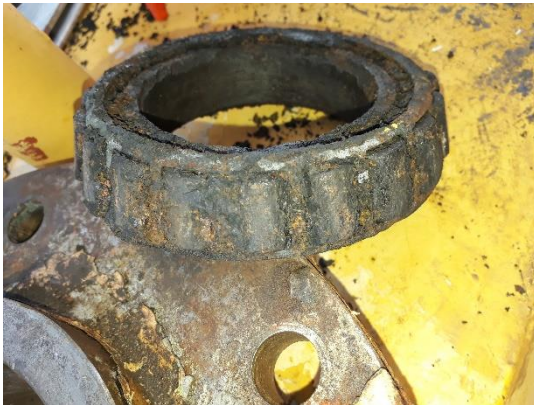
Worn rudder bearings

- Rudder bearings – “NTN” bearings supply from local market. (02nos)

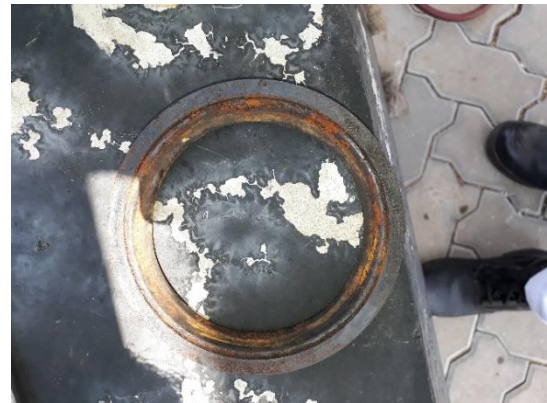
Worn rudder seals

- Rudder oil seals are not available in local market, therefore export from DUBAI. (04nos)

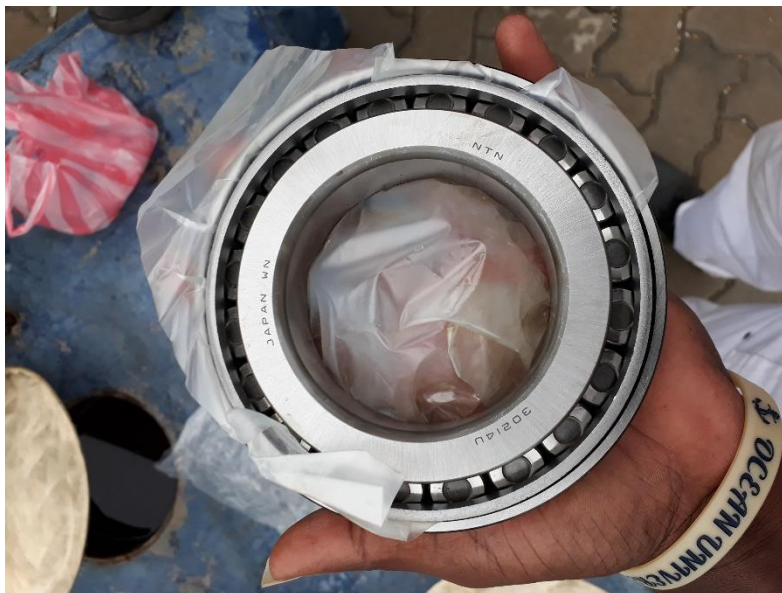
New NTN rudder bearings

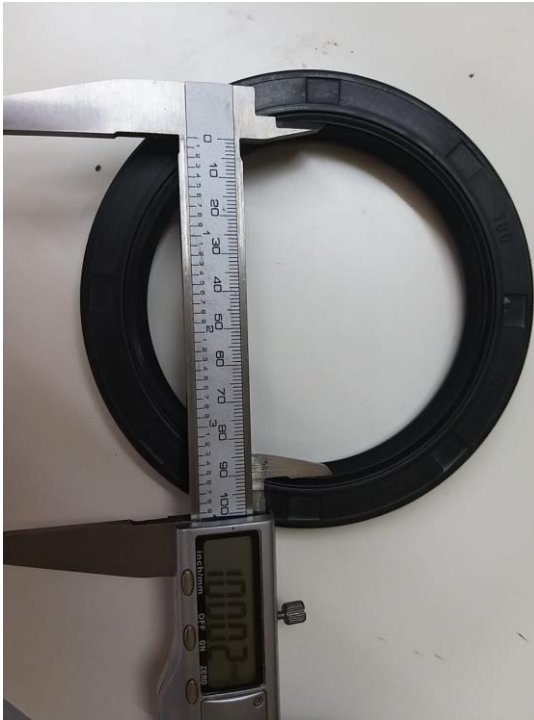
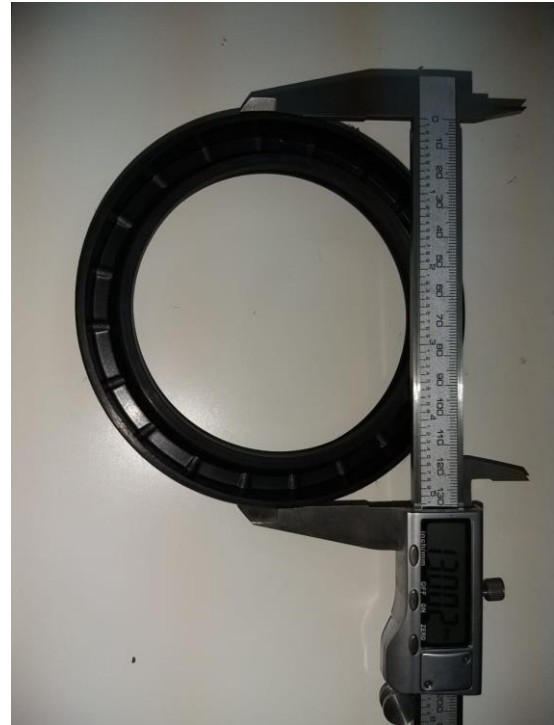
New rudder seals

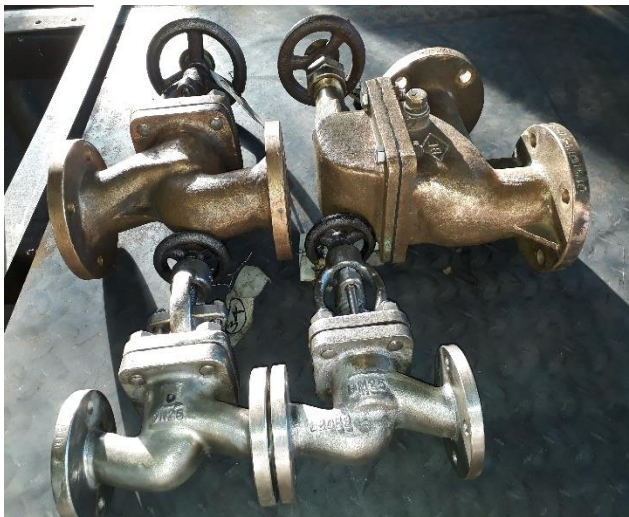
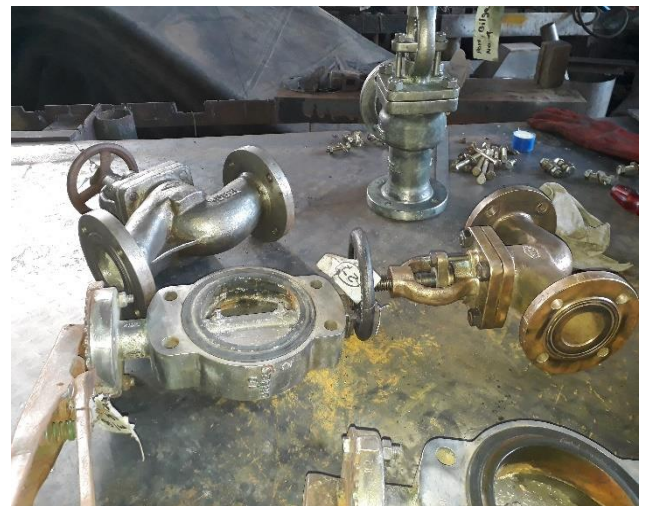
During valve service, after P testing

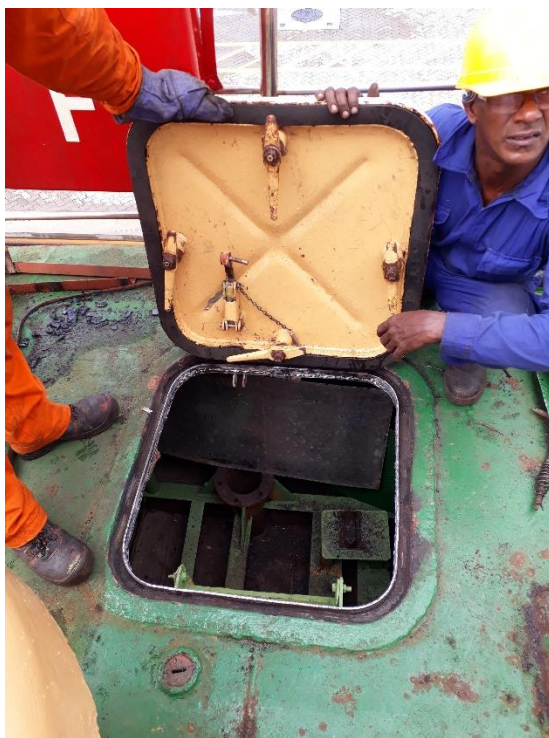
Hatch cover compression bar replace

- AFT tiller plat hatch cover compression bar and hatch coaming replace & chalk tested check weather proof.

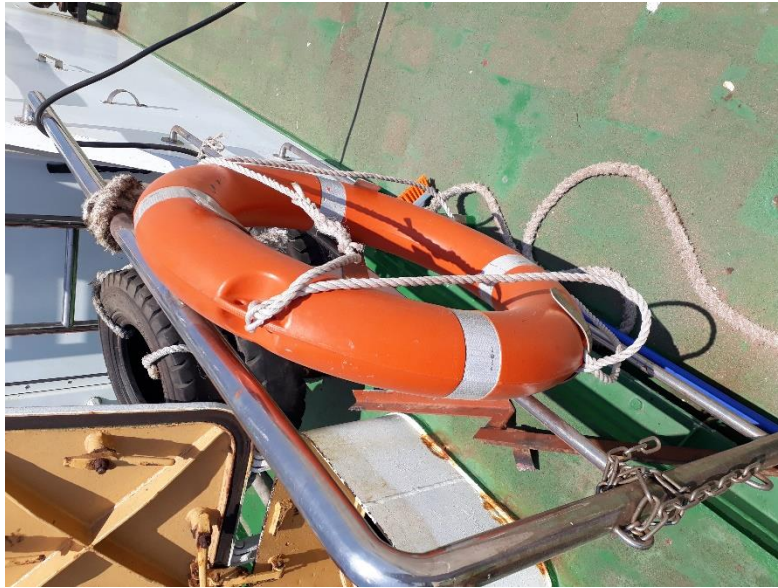
Life ring mounting repair

- Forward emergency S/S locking handle repair and refit – 04 nos S/S locking handles are cracked in welding joints, cut grove along with crack area and filling S/S materials by welding. One handle locking bar was broken and replace new S/S bar.
- AFT life ring mount cropped off and weld back inside of hand railing by S/S welding.

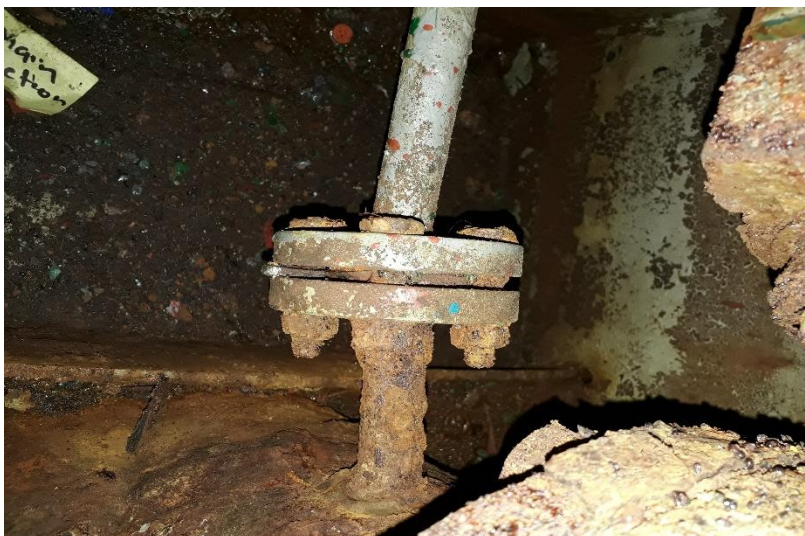
- Engine room pipe modification – Propeller shaft mechanical seal cooling sea water supply line from under of sea chest valve. Then due to this pipe & valve arrangement, if damage any area of the between strainer end to valve end water leaking cannot stop. So previous pipe line blank from strainer area and create new pipe section above the sea main sea chest valve.

Corroded shaft cooling line

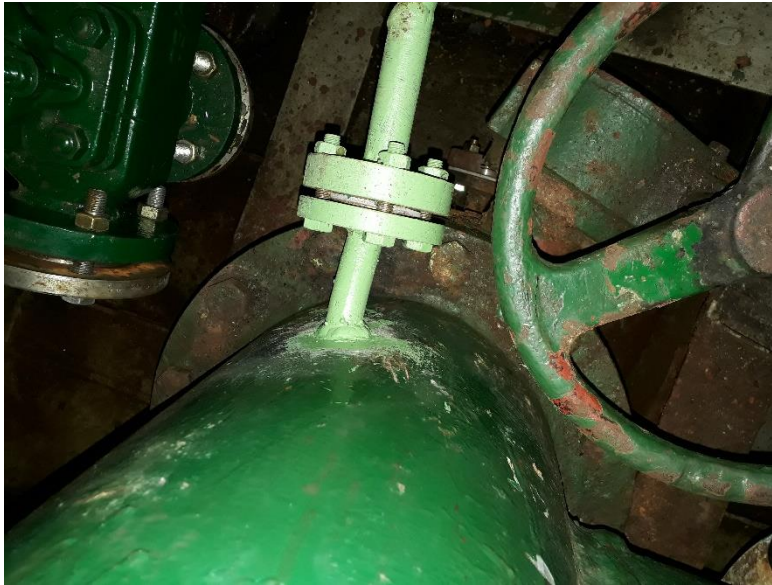
After pipe modification

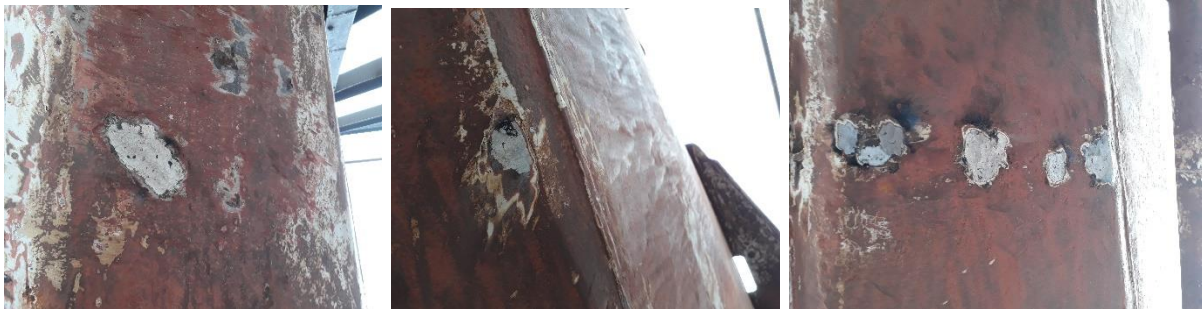
Cavitation filling

- Under water area cavitation filling with welding, grinding surface and apply paint to repair areas.
